# Retrospective Analysis of Estero Bay Seagrass Cover and Water Quality Trends

Lisa Rickards, MS Env Sci Candidate & James Douglass, PhD  
Florida Gulf Coast University

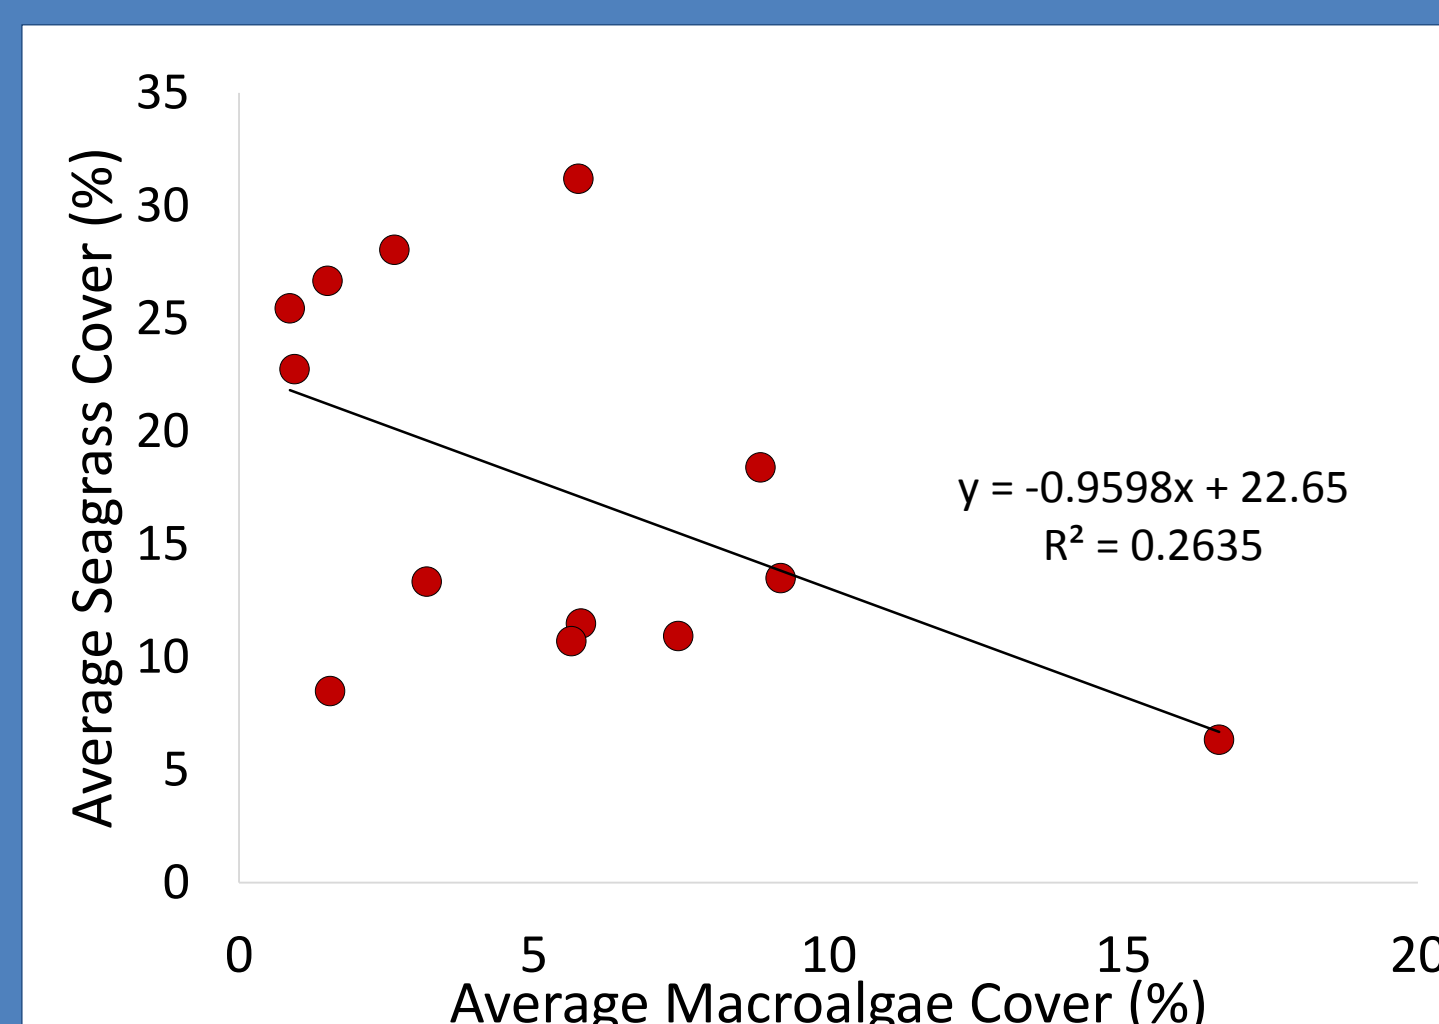
Figure 5. Correlation analysis for average seagrass cover and average macroalgae cover in Estero Bay from 2003-2016 (2004 excluded) from EBAP transect surveys.

- Potential sulfide poisoning<sup>11</sup>
- A strong negative relationship with macroalgae was found as well, which suggests harmful eutrophication is occurring in the Bay

- Macroalgae cover exceeded seagrass cover for the first time in 2016, suggesting that the estuary may have crossed a tipping point between seagrass and macroalgae dominance

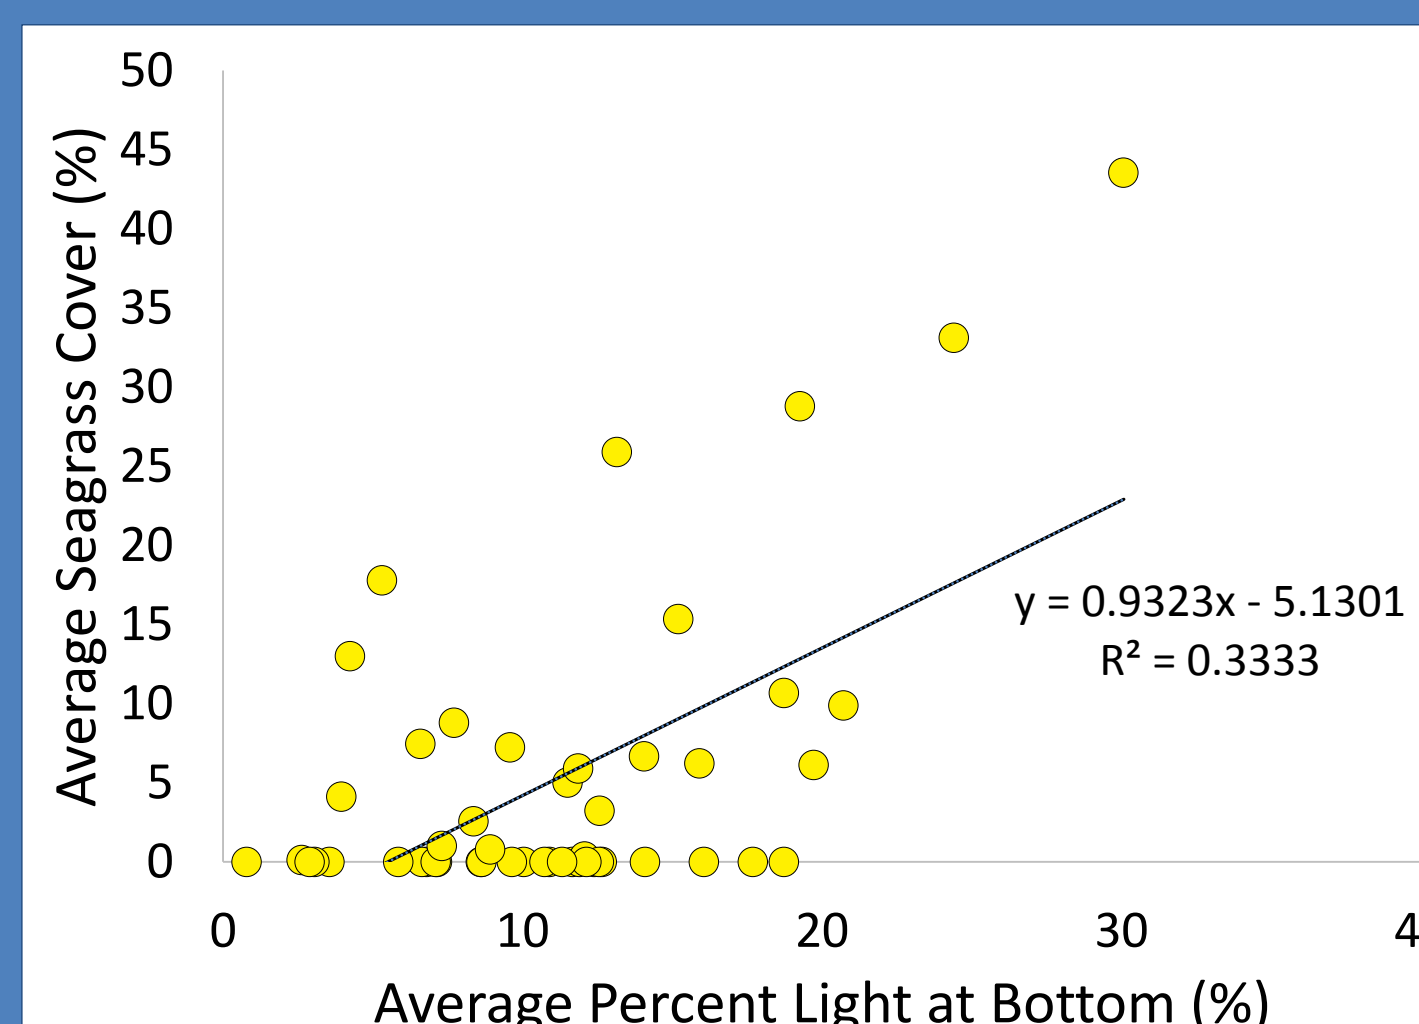
Figure 6. Correlation analysis for average seagrass cover and average percent light at bottom in Estero Bay from 2017 Bay-wide seagrass/optical water quality surveys.

- A strong positive correlation was found between 2017 average percent sunlight available at bottom and 2017 average seagrass coverage, suggesting reduced water clarity in the Bay may inhibit seagrass growth

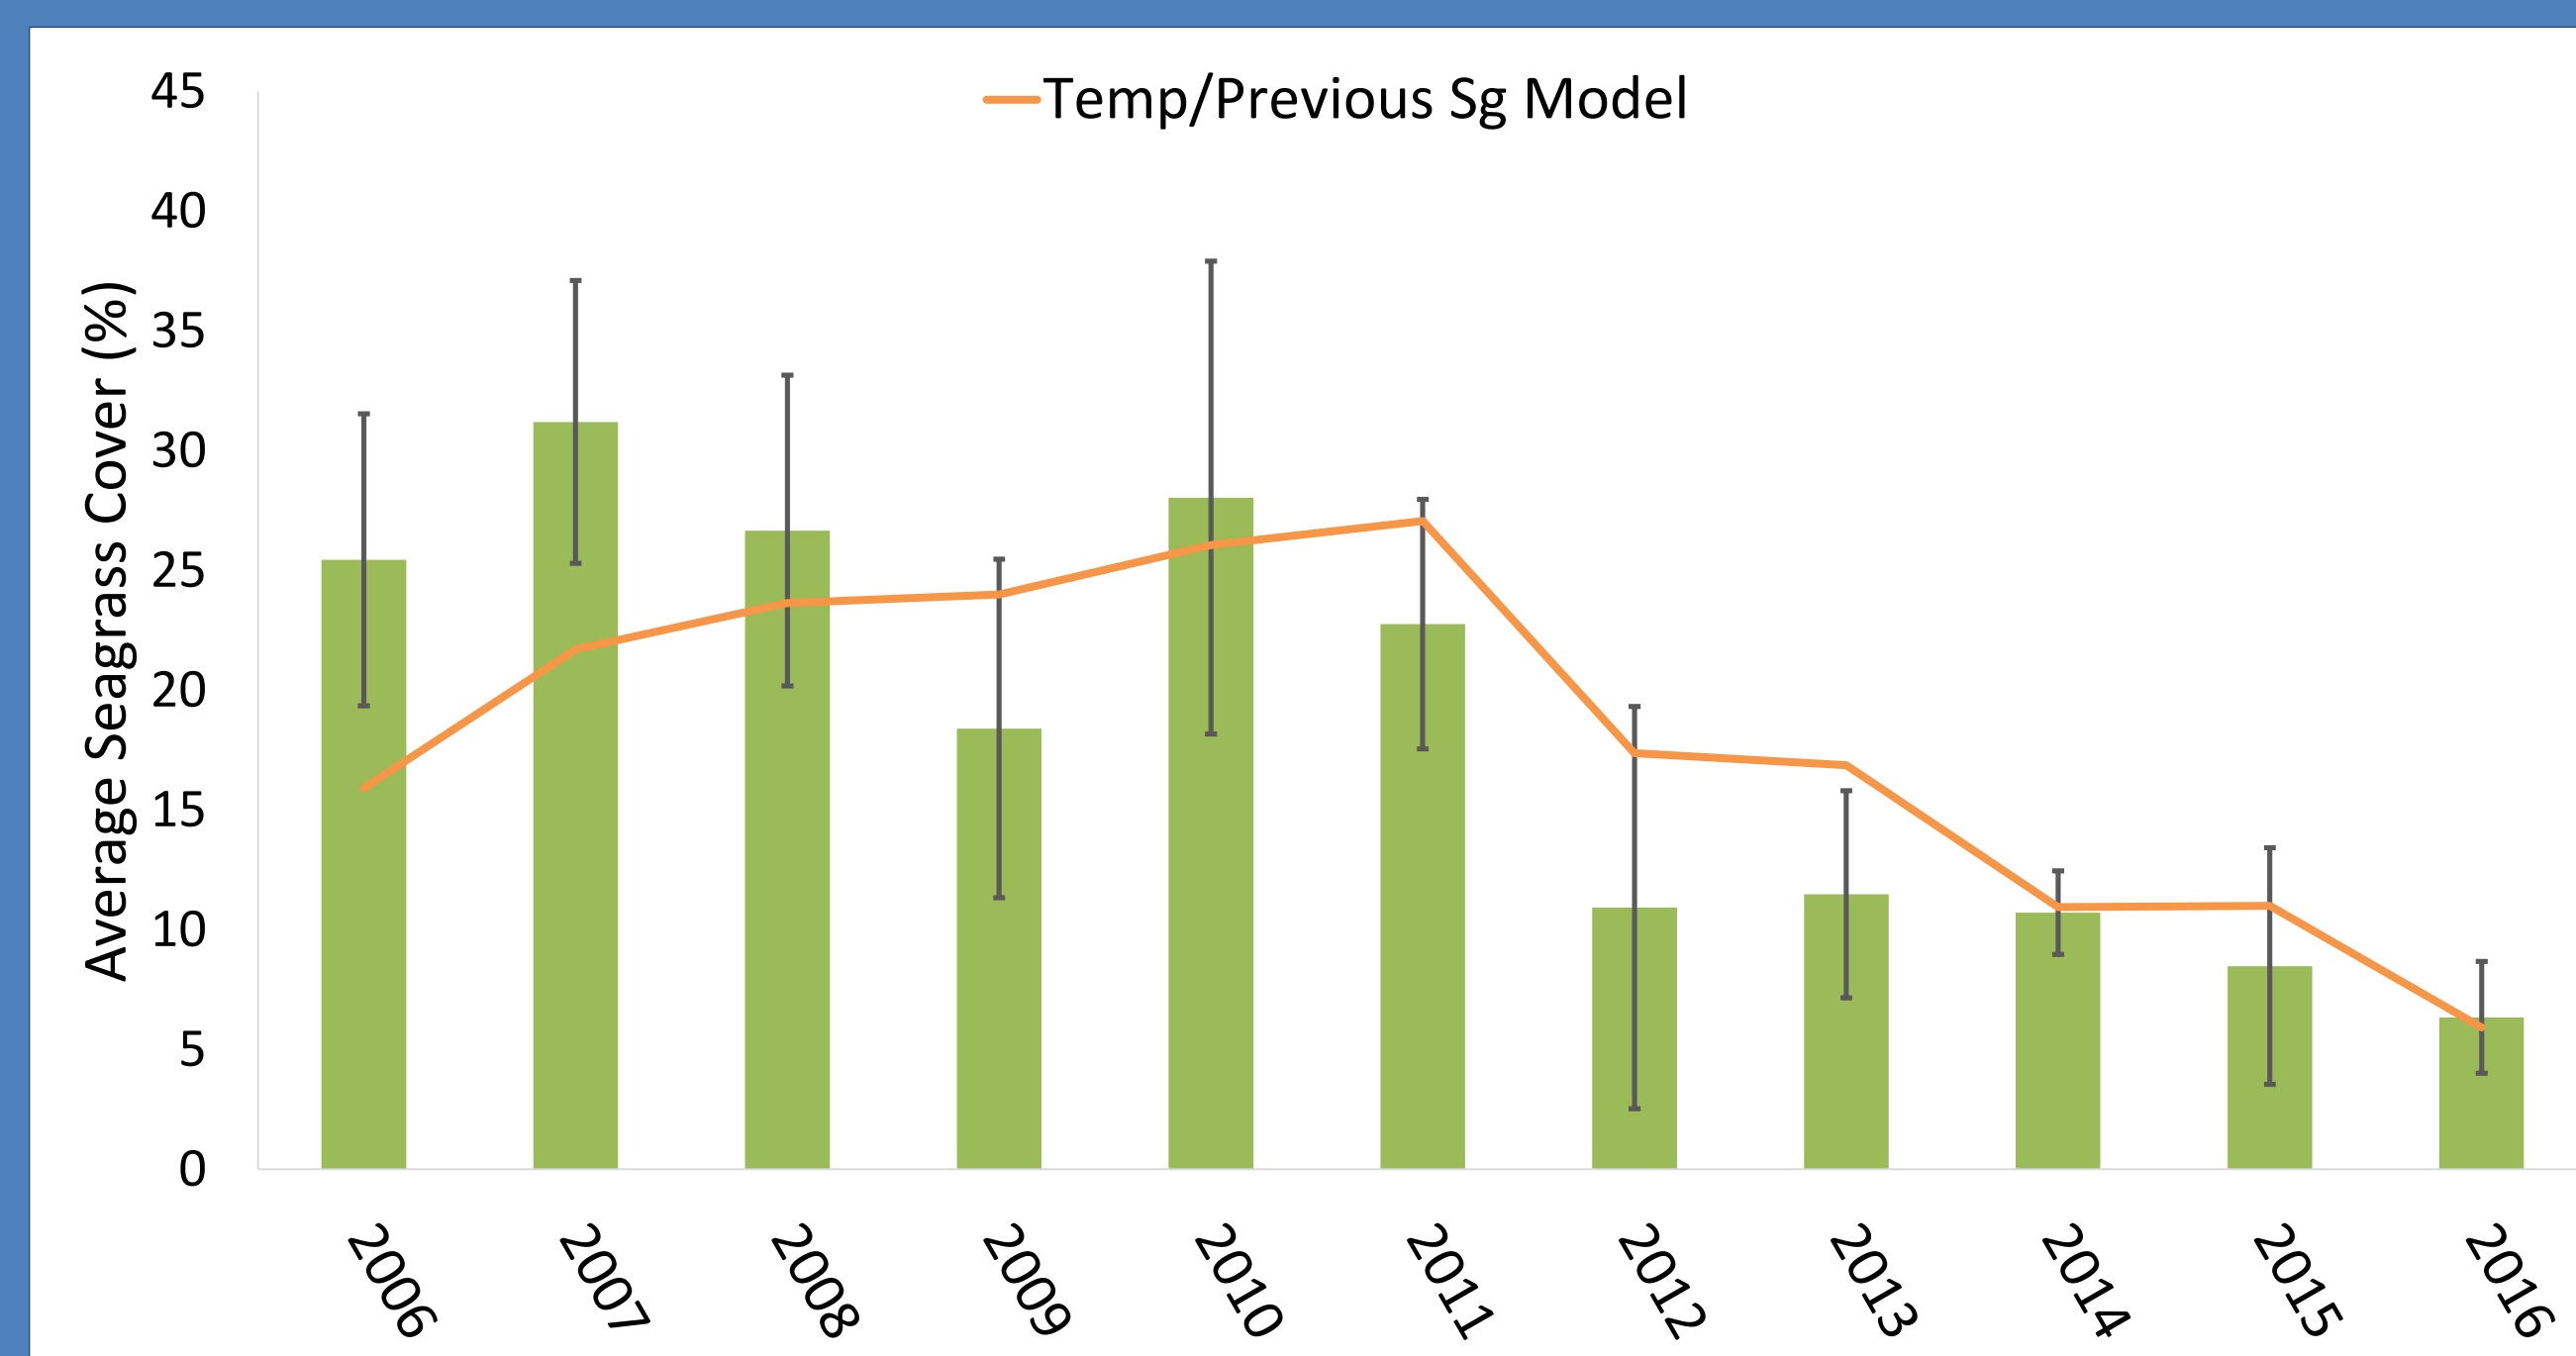
Figure 7. Average percent cover of seagrass in Estero Bay from 2006-2016 with best seagrass coverage predictor model (Nov. - Oct. average temperature (°C) and previous year average seagrass cover (%)).

- Regression analyses found a strong negative connection between annual seagrass trends and average annual temperature, meaning seagrass performance was worse during warmer years
